# Inspection Report

## Happy Homebuyer

**Property Address:**  
1234 Home Sweet Home  
Taylor Mill, KY. 41015

**JC Home Inspections, LLC**

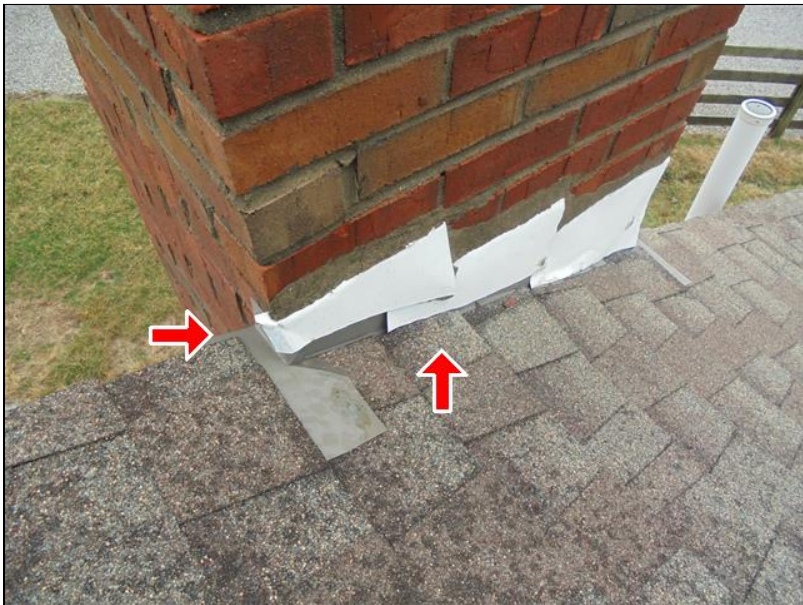
1.1 The chimney is not flashed properly. The chimney has step flashing and looks as if the cap flashing was added later and is not installed correctly. This is possibly the water intrusion point for the damage being done inside the attic. This does not appear adequate. It should be properly repaired or replaced. A qualified roofing contractor should inspect further and correct as needed.

1.1 Item 1(Picture) Chimney flashing incorrectly installed

The chimney is not flashed properly. The chimney has step flashing and looks as if the cap flashing was added later and is not installed correctly. This is possibly the water intrusion point for the damage being done inside the attic. This does not appear adequate. It should be properly repaired or replaced. A qualified roofing contractor should inspect further and correct as needed.

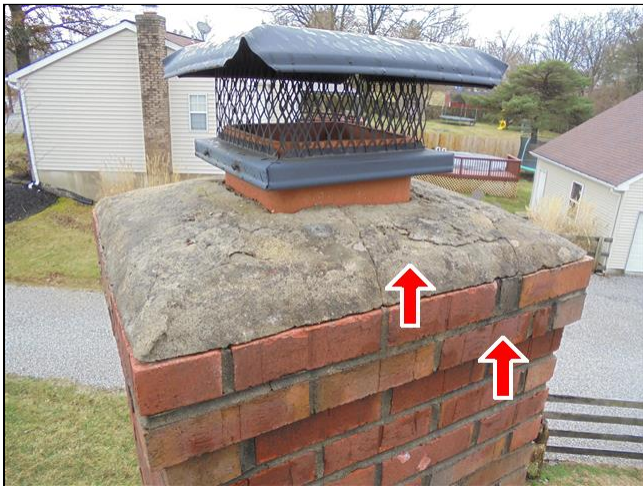
1.2 The cement crown on chimney is failing and cracked. Further deterioration may occur if not repaired. A qualified person should repair or replace as needed.

1.2 Item 1(Picture) Chimney crown

The cement crown on chimney is failing and cracked. Further deterioration may occur if not repaired. A qualified person should repair or replace as needed.

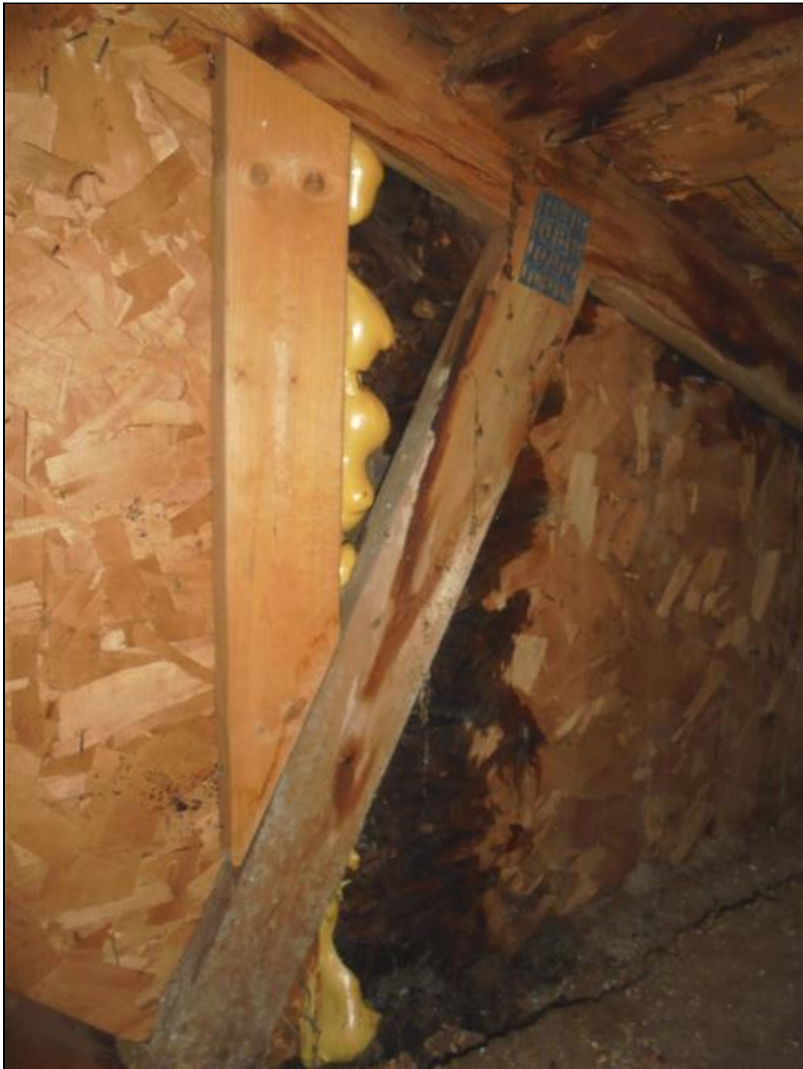
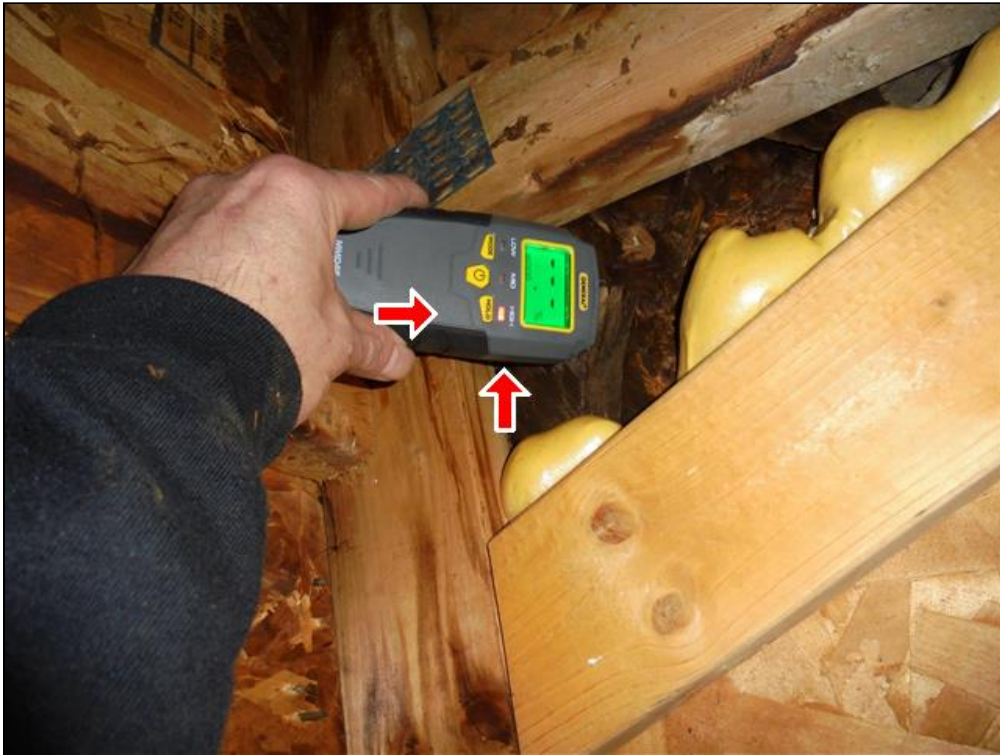
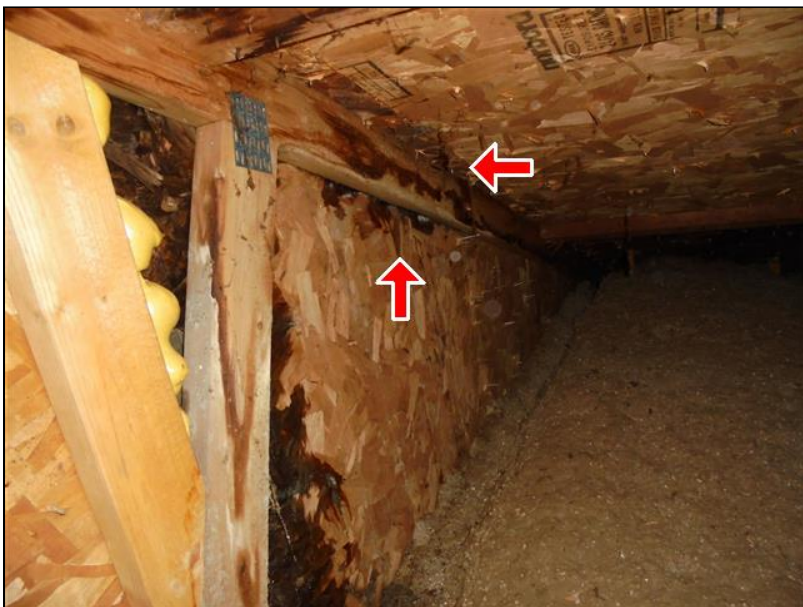
1.5 (1) Water signs are on plywood and manufactured joists in attic above garage resulting from a roof leak found around the chimney. A moisture meter was used and readings were around 31% or "wet" indicating leak still exists. A qualified roofing contractor should inspect further and correct as needed.

1.5 Item 1(Picture) Water damage in attic above family room

1.5 Item 2(Picture) Moisture meter went to high mark and beyond

1.5 Item 3(Picture) Moisture traveling down joist

(1) Water signs are on plywood and manufactured joists in attic above garage resulting from a roof leak found around the chimney. A moisture meter was used and readings were around 31% or "wet" indicating leak still exists. A qualified roofing contractor should inspect further and correct as needed.

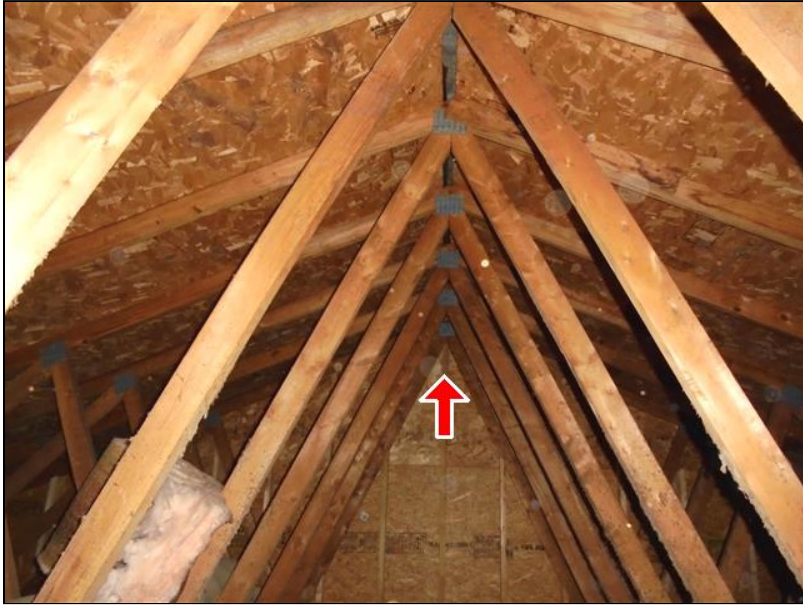
(2) When the attic is dark above garage you can see daylight on chimney side of house at ridge. Recommend sealing to prevent water intrusion.

1.5 Item 4(Picture) Daylight showing in attic

(2) When the attic is dark above garage you can see daylight on chimney side of house at ridge. Recommend sealing to prevent water intrusion.

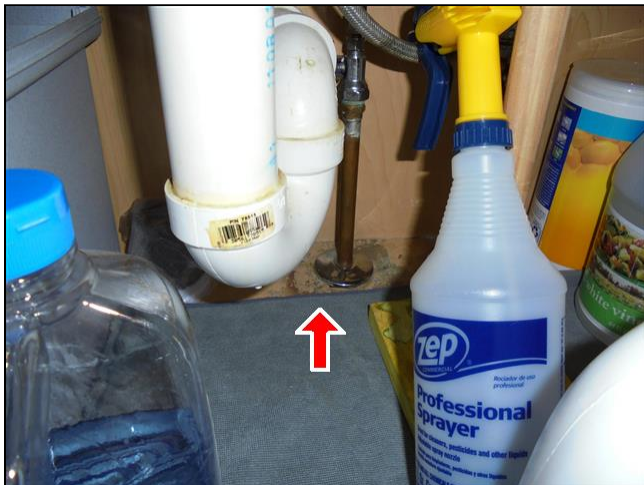
**4.5** The base cabinetry sags or is warped under kitchen sink at bottom (from a previous leak). This is a cosmetic issue for your information. Was not leaking at the time of inspection.

4.5 Item 1(Picture) Prior water damage under sink

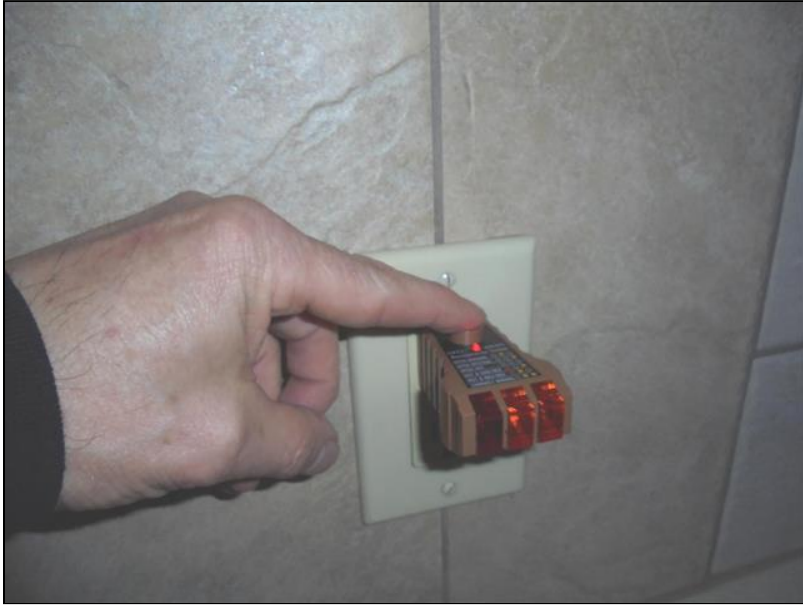
4.8 The GFCI (Ground Fault Circuit Interrupter) outlet did not trip when tested (defective) on the right side of the kitchen sink. Further inspection is needed by a qualified licensed electrical contractor. I recommend repair as needed.

4.8 Item 1(Picture) GFCI not working Kitchen

The GFCI (Ground Fault Circuit Interrupter) outlet did not trip when tested (defective) on the right side of the kitchen sink. Further inspection is needed by a qualified licensed electrical contractor. I recommend repair as needed.

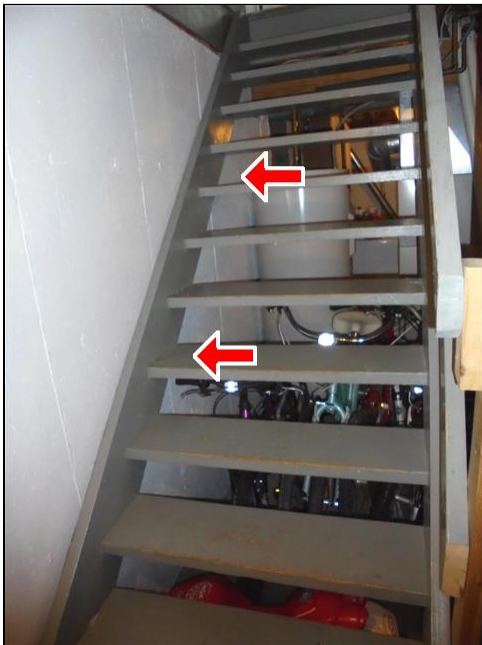
**5.3 (1)** The stairs to the basement are not mounted to the wall and sway back and forth slightly. A more proper repair is needed to ensure stability or an injury might occur. A qualified person should repair or replace as needed.

5.3 Item 1(Picture) Basement steps loose, not secured to wall

(1) The stairs to the basement are not mounted to the wall and sway back and forth slightly. A more proper repair is needed to ensure stability or an injury might occur. A qualified person should repair or replace as needed.

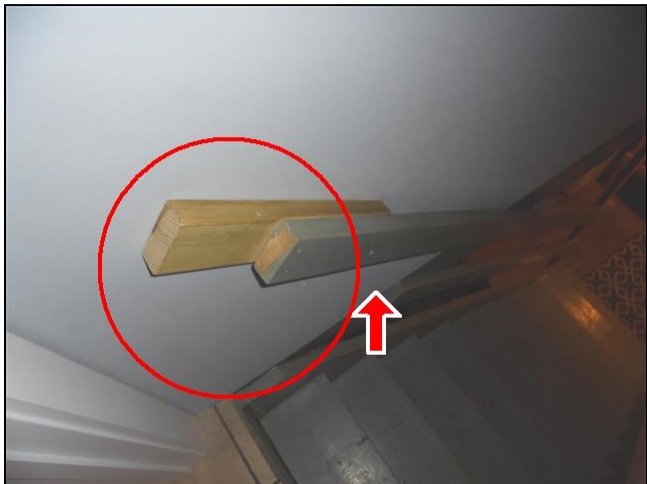
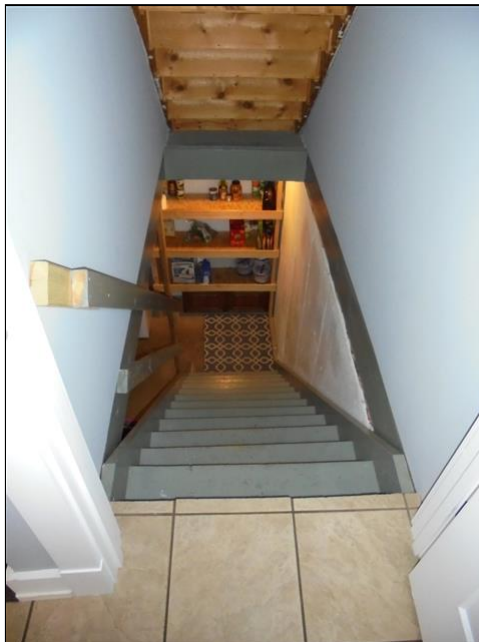
(2) The handrail for the stairs to lower level starts too far down the steps to be safe. A longer handrail should be installed for safety. A fall or injury could occur if not corrected. A qualified contractor should repair or replace as needed .

5.3 Item 2(Picture) Improper handrail

5.3 Item 3(Picture) Stairs to basement

(2) The handrail for the stairs to lower level starts too far down the steps to be safe. A longer handrail should be installed for safety. A fall or injury could occur if not corrected. A qualified contractor should repair or replace as needed .

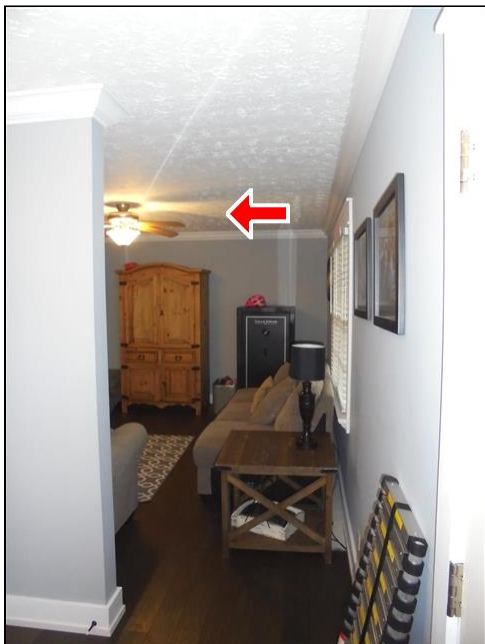
5.6 (1) The ceiling fan light in the living room to the right of the front door flashed off and on twice when I arrived. It worked fine after that, possibly a short in the wiring or a bad bulb. Electrical issues are considered a hazard until repaired. I recommend monitoring and repair as needed.

5.6 Item 1(Picture) Ceiling fan in living room possible short

(1) The ceiling fan light in the living room to the right of the front door flashed off and on twice when I arrived. It worked fine after that, possibly a short in the wiring or a bad bulb. Electrical issues are considered a hazard until repaired. I recommend monitoring and repair as needed.

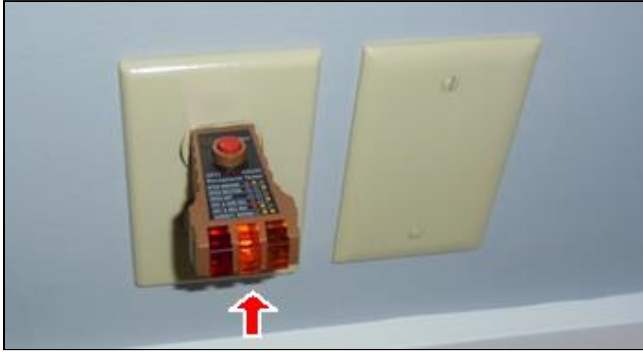
(2) The outlet to the left of the door as you go into the bedroom at the top of stairs has an outlet that is showing open ground. Recommend a licensed electrician repair as necessary.

5.6 Item 2(Picture) Bedroom top of stairs

(2) The outlet to the left of the door as you go into the bedroom at the top of stairs has an outlet that is showing open ground. Recommend a licensed electrician repair as necessary.

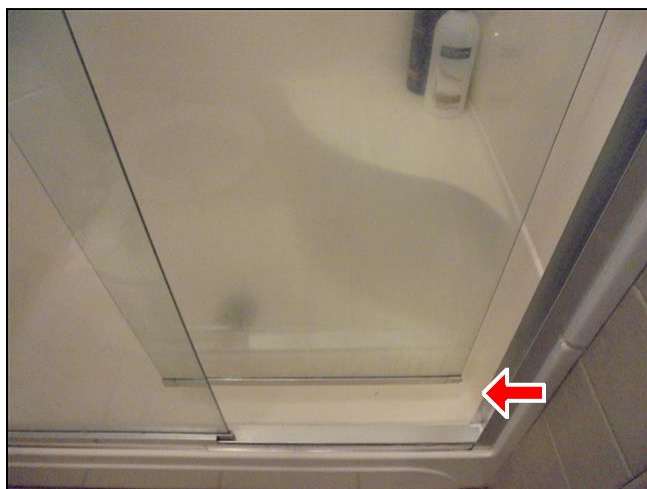
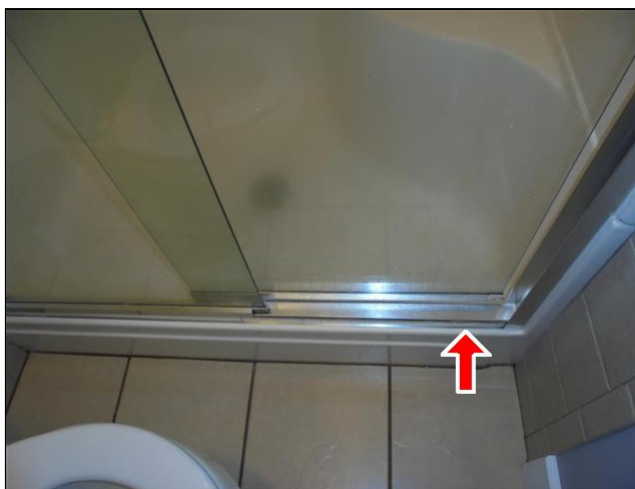
**6.5** The shower door in the master bath is not in a track at the bottom allowing the door to swing inwards and possibly drop off upper track. This is just for your information. I recommend repair or replace as necessary.

6.5 Item 1(Picture) Bottom of shower door not on track

6.5 Item 2(Picture) Shower door in the closed position

The shower door in the master bath is not in a track at the bottom allowing the door to swing inwards and possibly drop off upper track. This is just for your information. I recommend repair or replace as necessary.

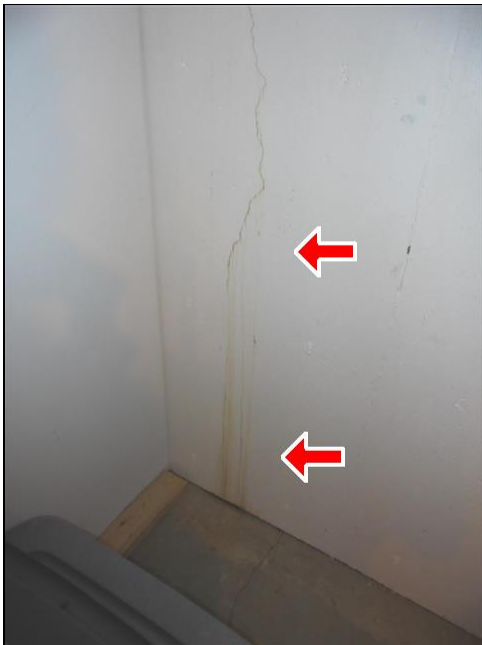
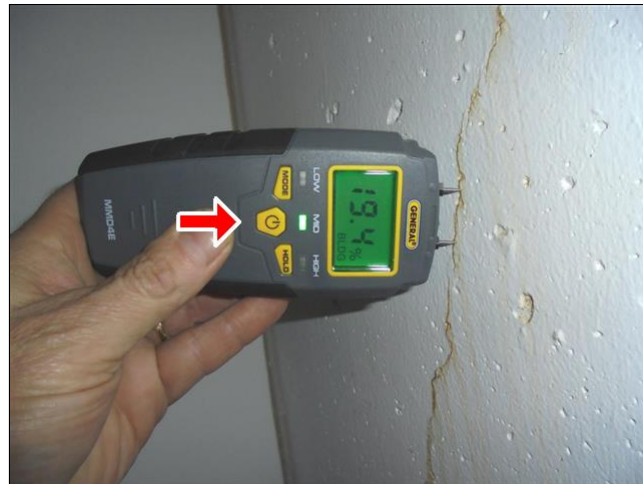
**7.0 (1)** Visible signs of water intrusion in the basement are present from water stains on the wall under the incoming gas line. Though it does appear minor, it does still indicate water intrusion. It is recommend to monitor and repair as needed.

7.0 Item 1(Picture) Water staining wall

7.0 Item 2(Picture) Moisture meter showing medium moisture in the area

(1) Visible signs of water intrusion in the basement are present from water stains on the wall under the incoming gas line. Though it does appear minor, it does still indicate water intrusion. It is recommend to monitor and repair as needed.

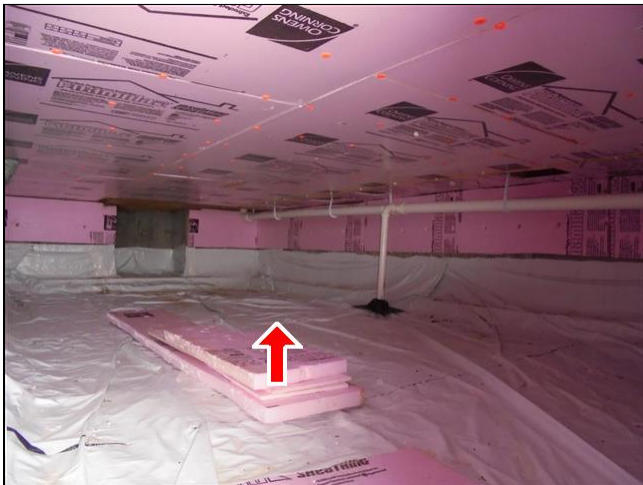
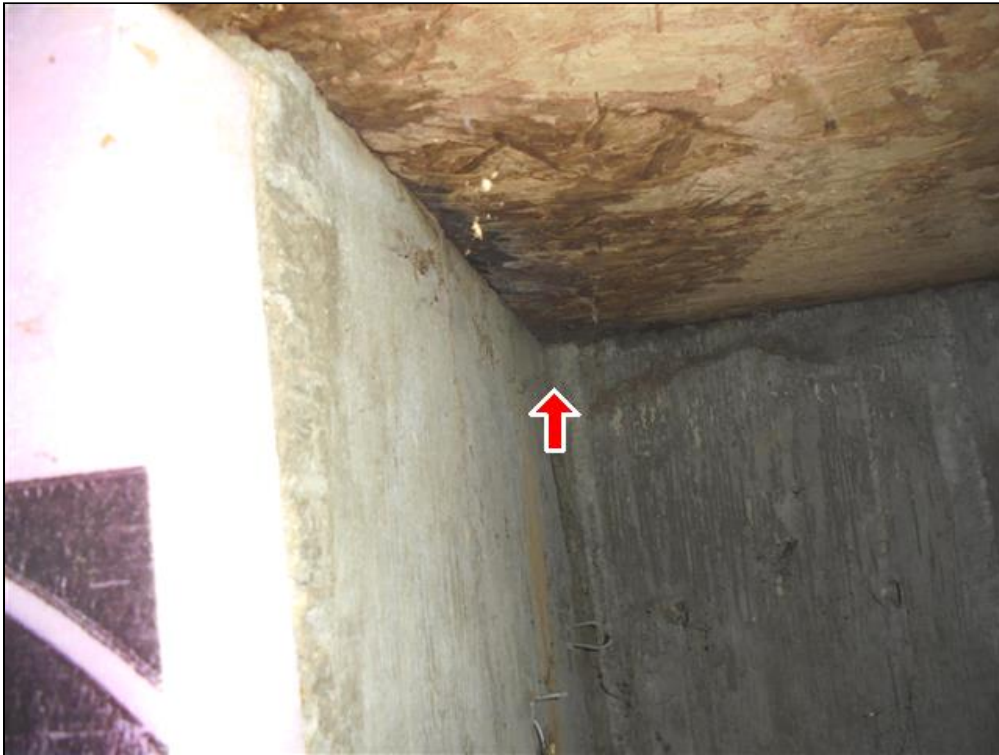
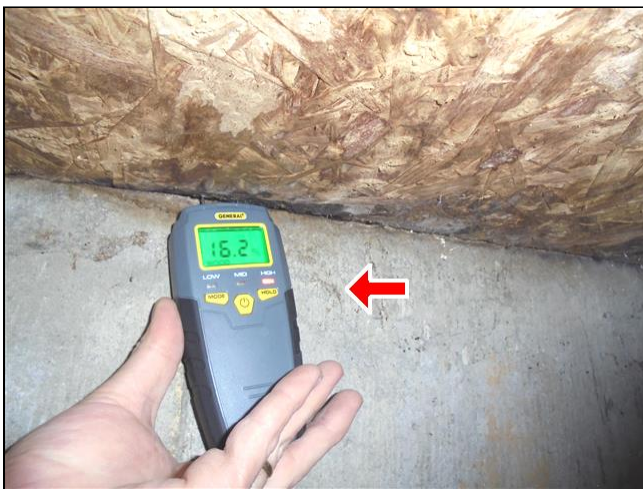
(2) Visible signs of water intrusion in the crawlspace are present from standing water under the plastic vapor barrier at the back right corner and from water stains on wood sheathing under fireplace. Water intrusion can lead to more costly repairs and increase damage if not corrected.. I recommend further investigation or correction by a qualified licensed contractor or water infiltration specialist.

7.0 Item 3(Picture) Area of vapor barrier where water is pooling under barrier

7.0 Item 4(Picture) Moisture intrusion under chimney in crawlspace.

7.0 Item 5(Picture) 16.2 High level of moisture at chimney base

(2) Visible signs of water intrusion in the crawlspace are present from standing water under the plastic vapor barrier at the back right corner and from water stains on wood sheathing under fireplace. Water intrusion can lead to more costly repairs and increase damage if not corrected.. I recommend further investigation or correction by a qualified licensed contractor or water infiltration specialist.

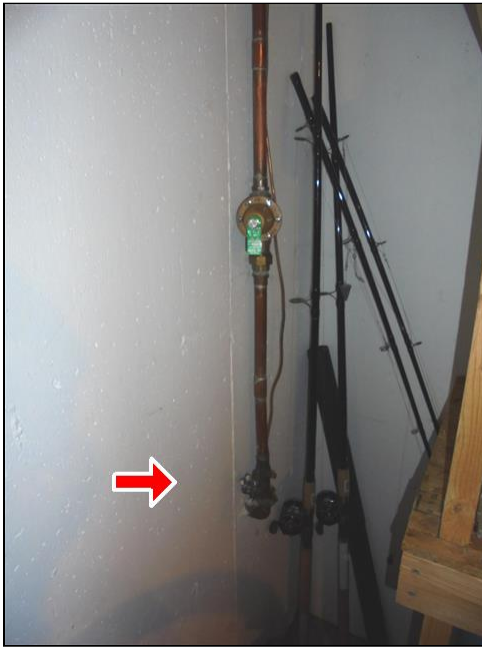
**8.3** The main shut off is the knob located in the basement at the front right corner. This is for your information.

8.3 Item 1(Picture) Main water shut off

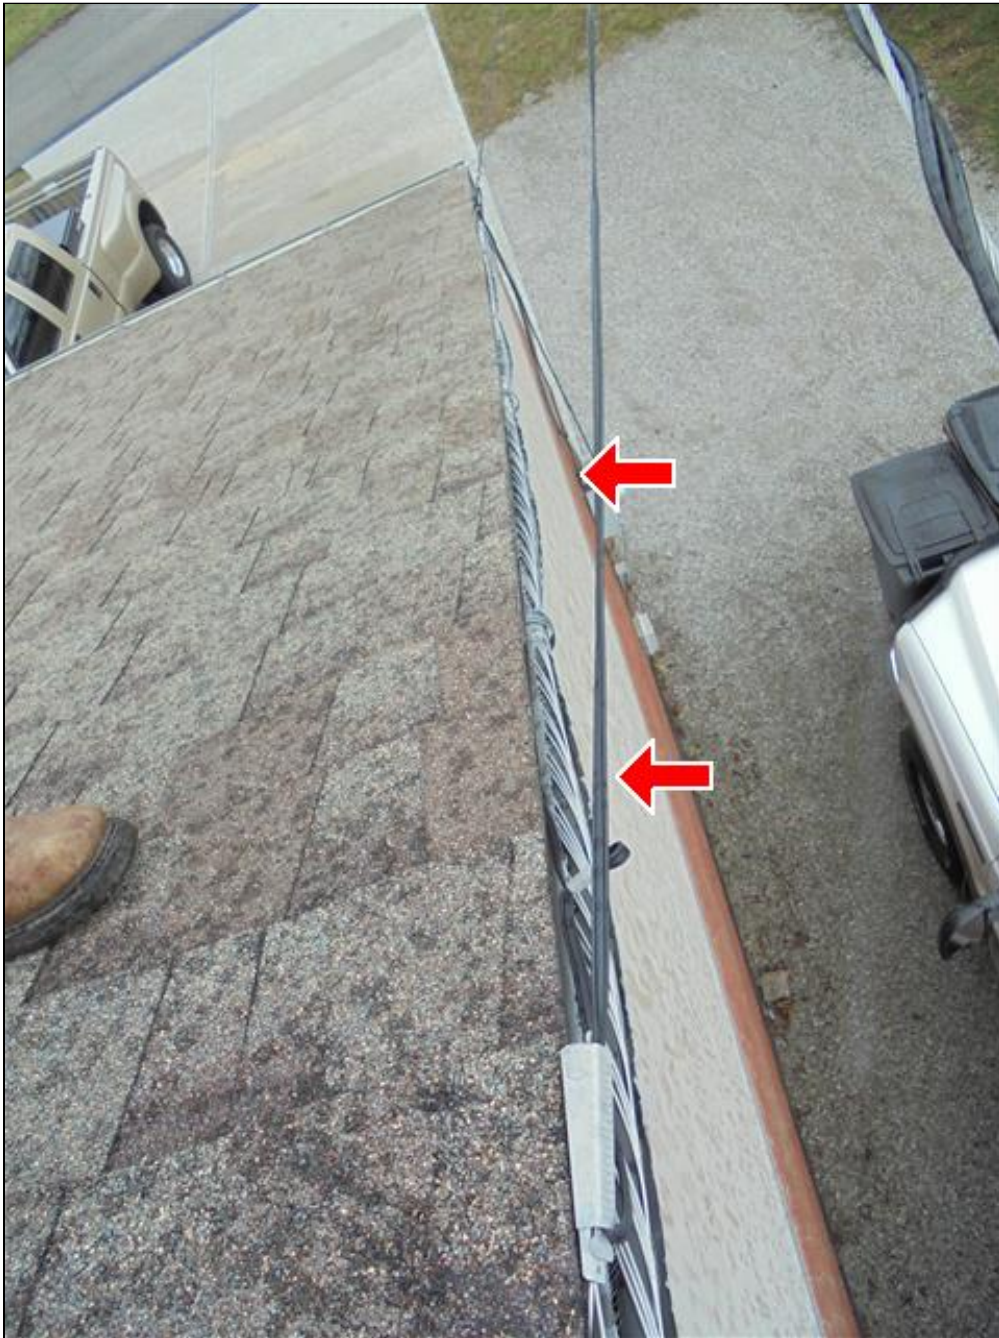
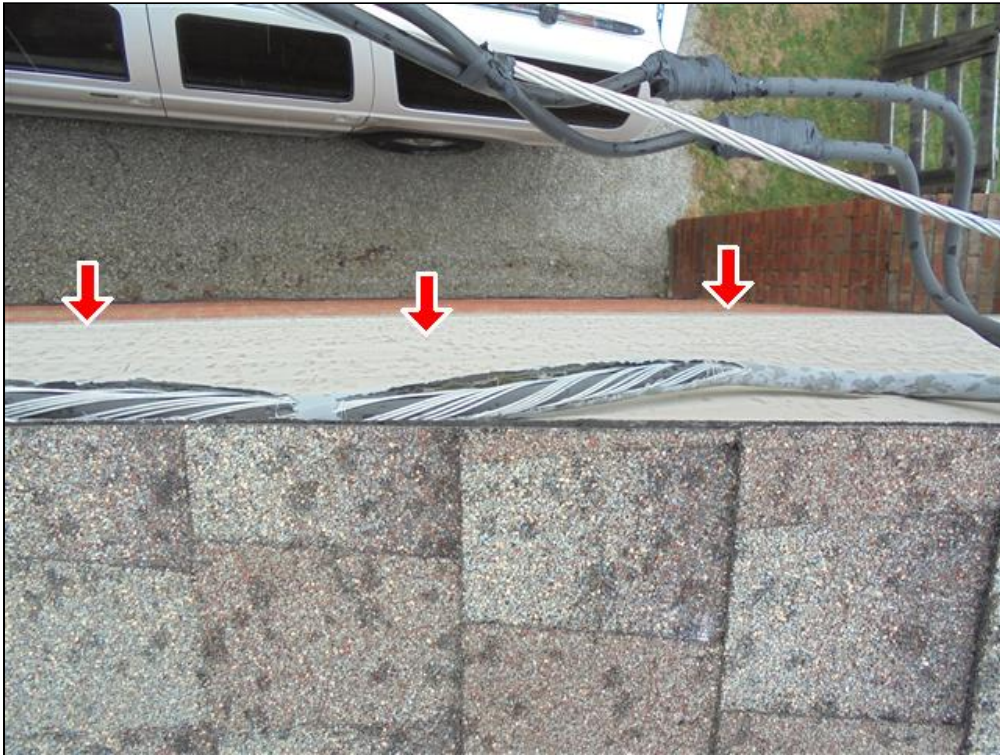
9.0 The electrical service conductors are frayed at wire sheathing outside and needs repair or replace.

9.0 Item 1(Picture) Wire sheathing split going down side of house

9.0 Item 2(Picture) Split wire sheathing

The electrical service conductors are frayed at wire sheathing outside and needs repair or replace.

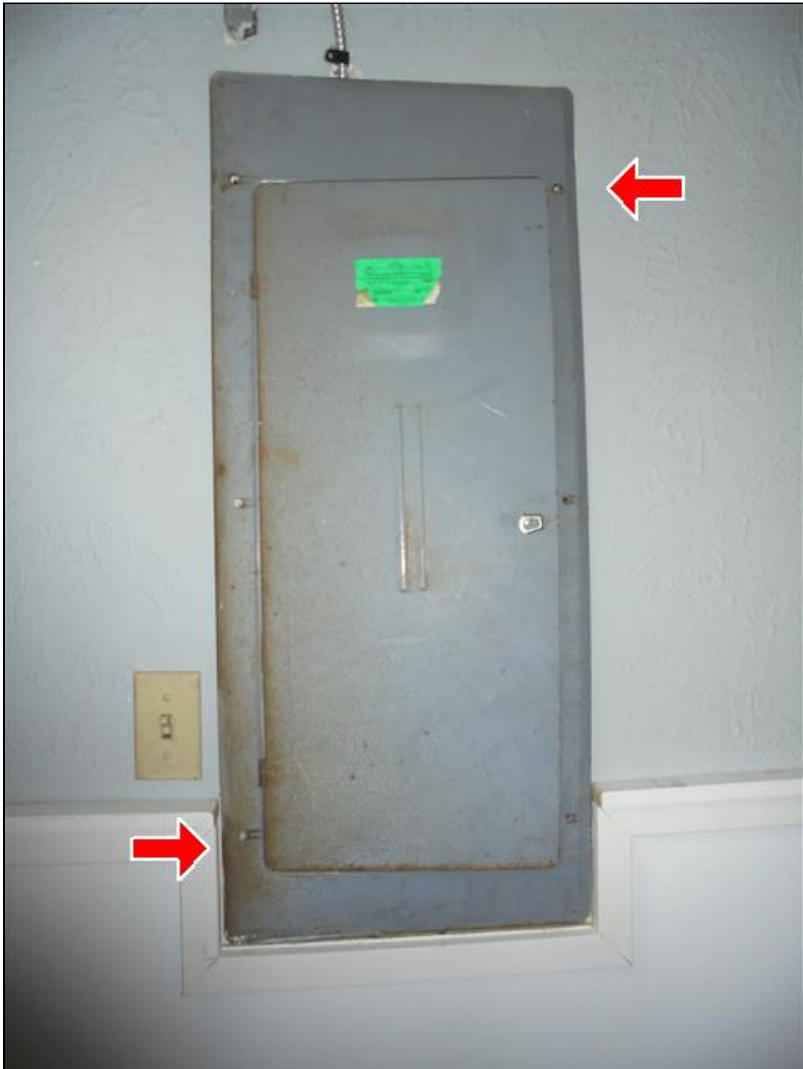
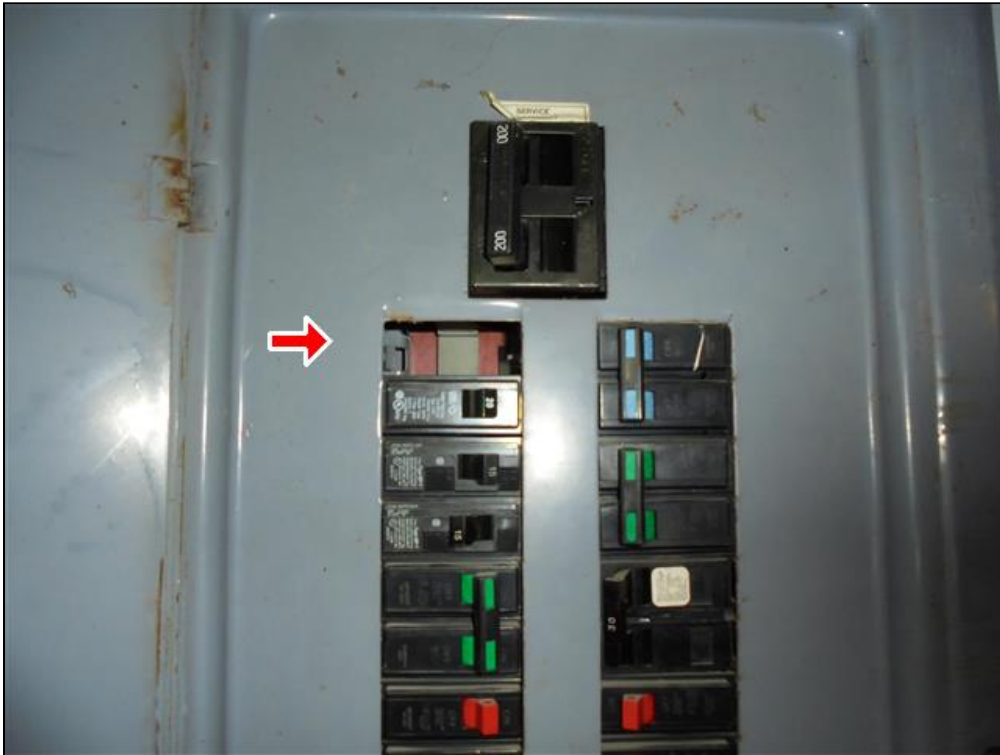
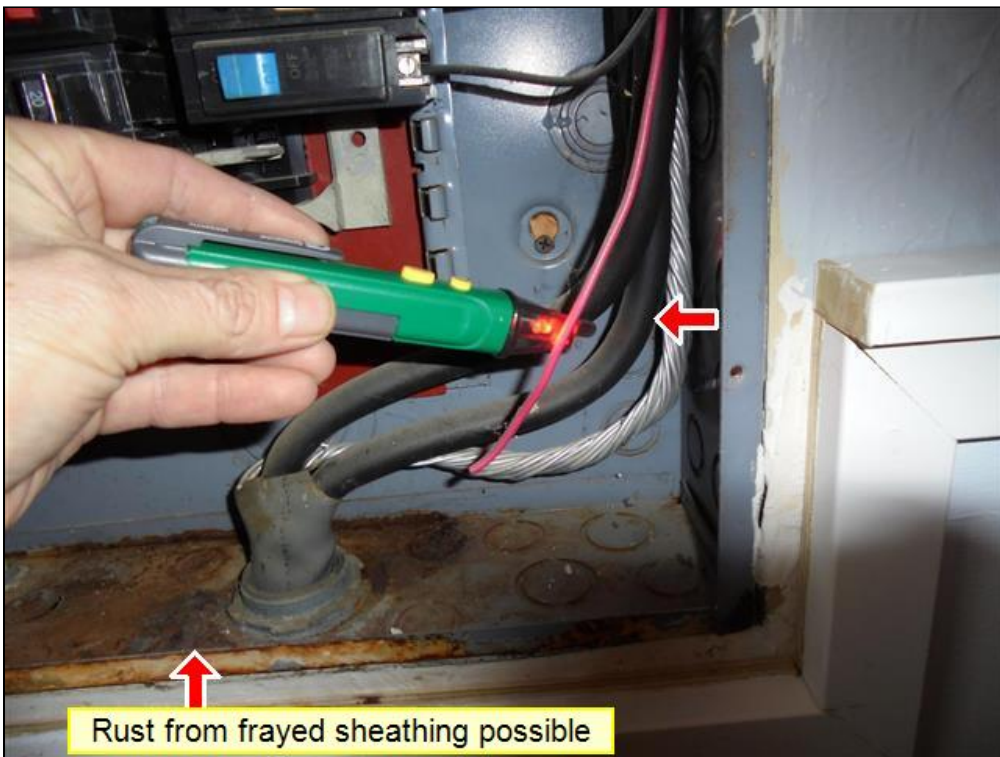
9.1 The problem(s) discovered in the panel such as knock-out missing on panel, random hot wire hanging down, rust in bottom, 4 of the 6 mounting screws missing and any other problems that an electrical contractor may discover while performing repairs need correcting. I recommend a licensed electrical contractor inspect further and correct as needed.

9.1 Item 1(Picture) Only 2 screws securing box cover

9.1 Item 2(Picture) Missing knockout cover

9.1 Item 3(Picture) Hot wire hanging free in box and rust

The problem(s) discovered in the panel such as knock-out missing on panel, random hot wire hanging down, rust in bottom, 4 of the 6 mounting screws missing and any other problems that an electrical contractor may discover while performing repairs need correcting. I recommend a licensed electrical contractor inspect further and correct as needed.

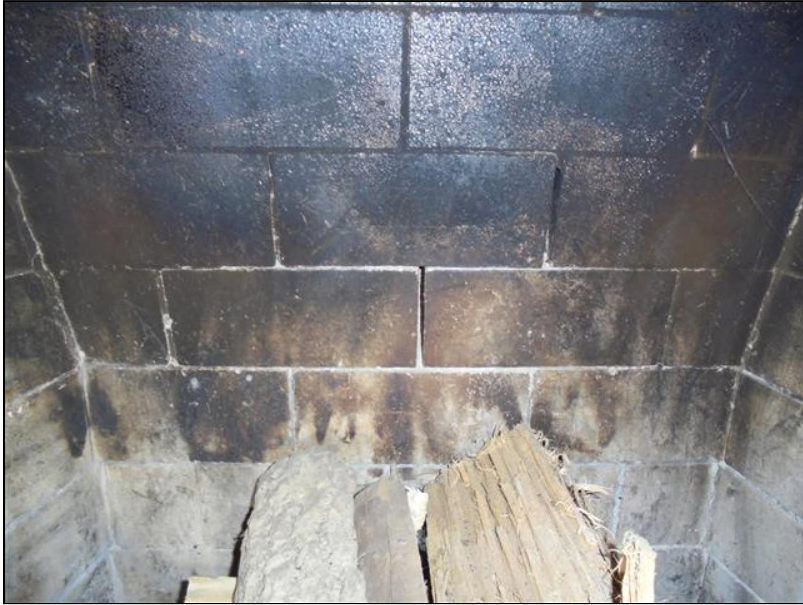
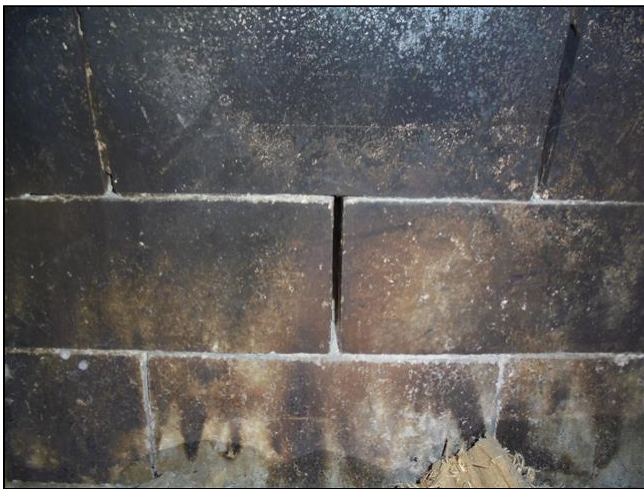
10.5 The mortar is missing in between some of the fire brick inside the fireplace. Recommend a qualified repair person fill the cracks and have the fireplace inspected before using.

10.5 Item 1(Picture) Missing mortar

10.5 Item 2(Picture) Close-up of missing mortar

The mortar is missing in between some of the fire brick inside the fireplace. Recommend a qualified repair person fill the cracks and have the fireplace inspected before using.

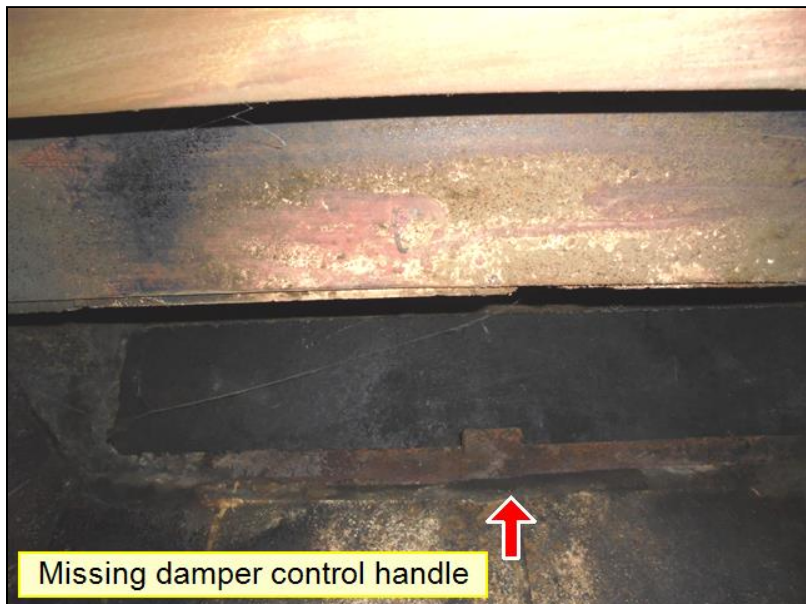
10.7 The damper arm and linkage for fireplace at the living room is missing. Repairs should be made so unit works properly. A qualified person should repair or replace as needed.

10.7 Item 1(Picture) Missing damper arm

The damper arm and linkage for fireplace at the living room is missing. Repairs should be made so unit works properly. A qualified person should repair or replace as needed.

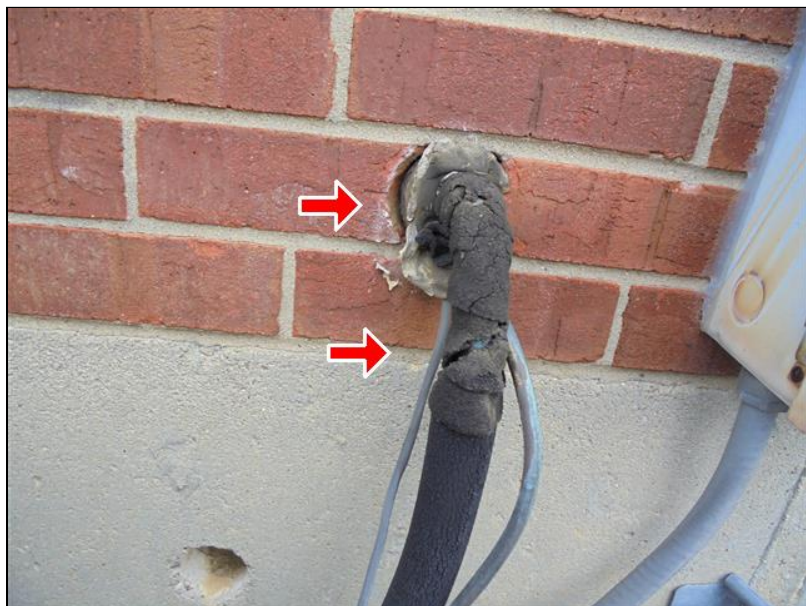
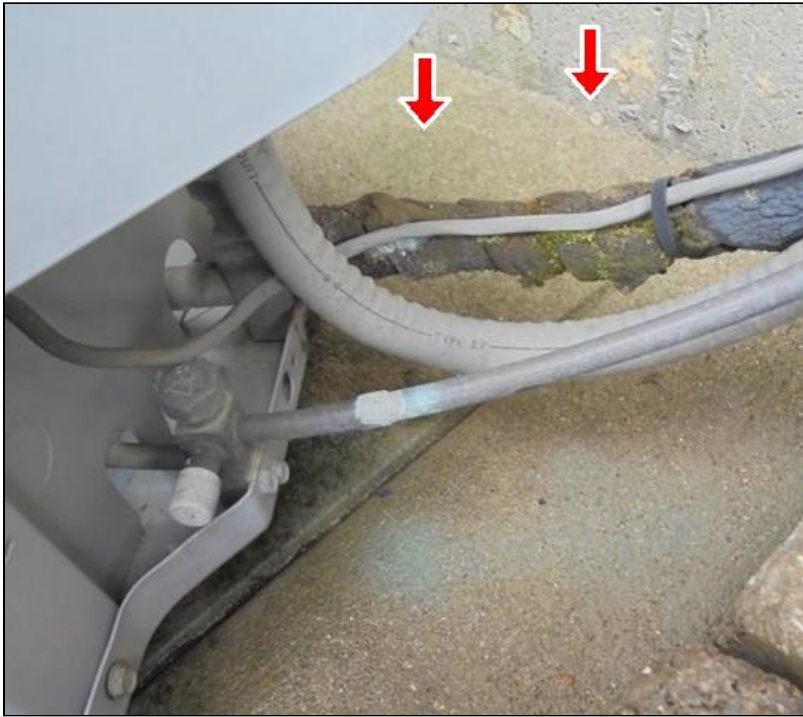
(2) The foam sleeve on suction line is damaged area(s) at outside unit. Missing or damaged foam on suction line can cause energy loss and condensation. I recommend service or repair as needed.

10.8 Item 1(Picture) Damaged foam sleeve

10.8 Item 2(Picture) Damaged foam sleeve

(2) The foam sleeve on suction line is damaged area(s) at outside unit. Missing or damaged foam on suction line can cause energy loss and condensation. I recommend service or repair as needed.
